Sediment supply conditions and channel response to the 2017 and 2018 flood events in Guichon Creek

Broad objectives

Specific research questions

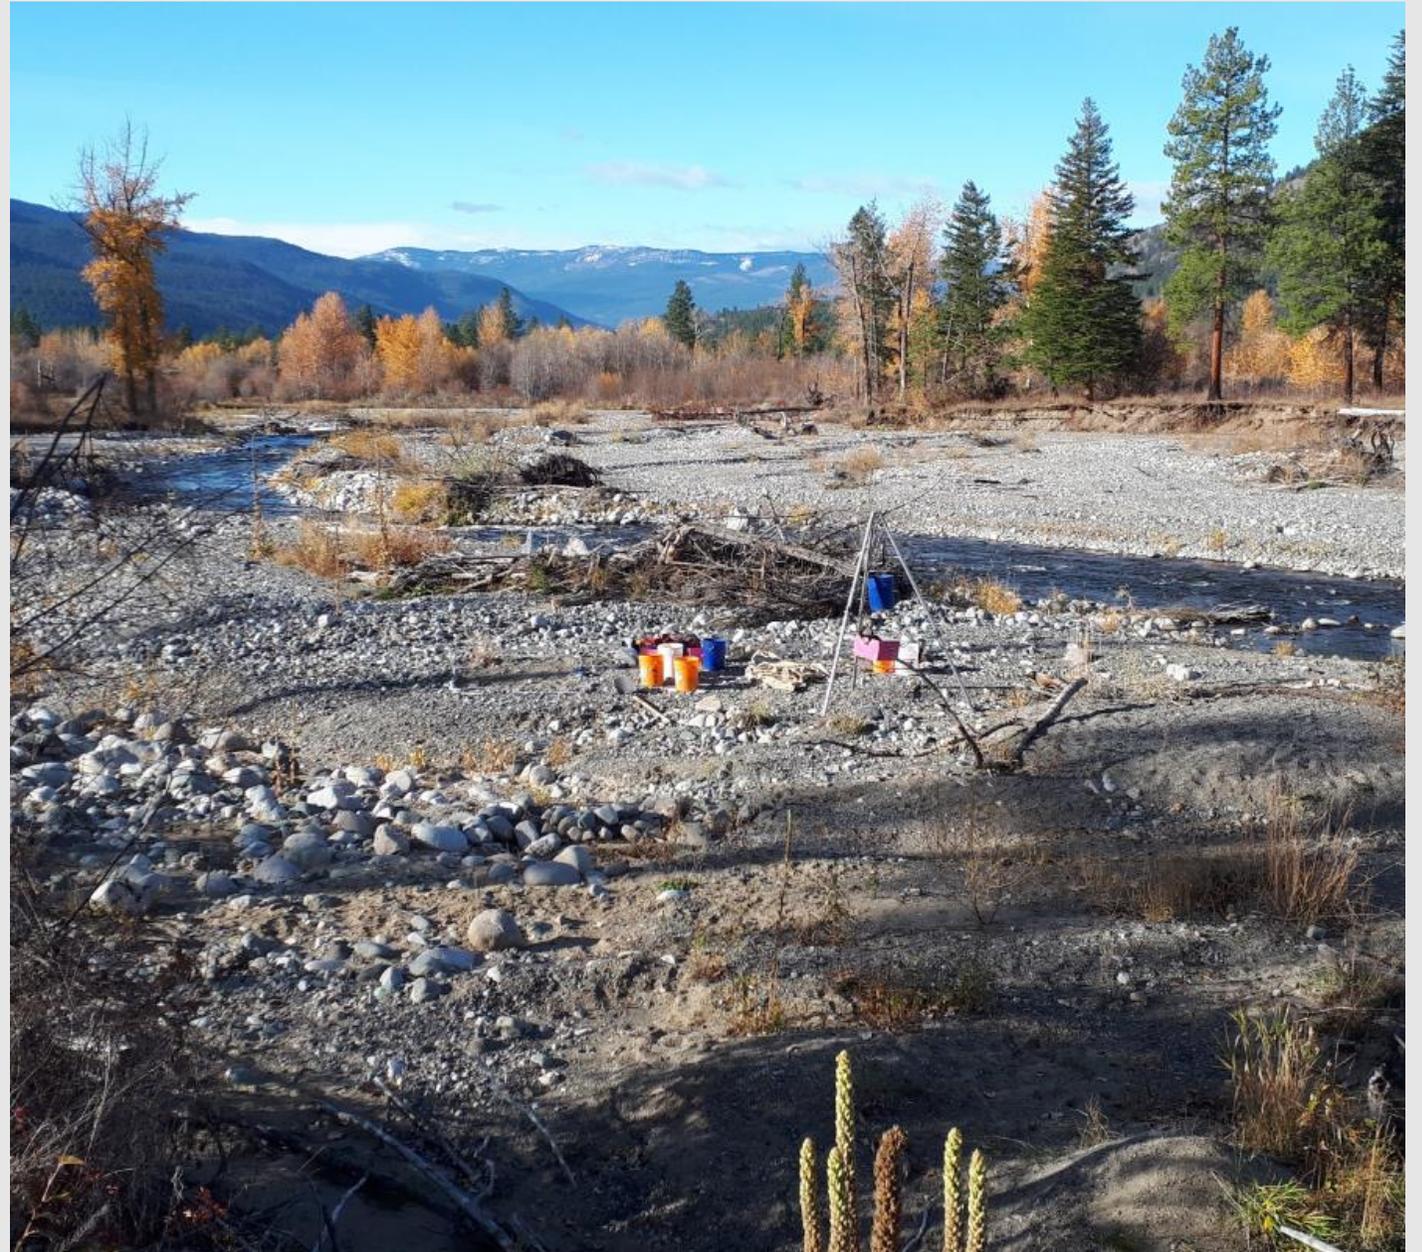
- **Sediment source volume**
 - Lidar data, airphotos, field inspection
- **Sediment texture**
 - Field sampling – pebble counts and bulk samples
- **Background transport capacity**
 - Calculated – 2 methods
- **Channel bed elevation change**
 - Lidar data, surface subtraction

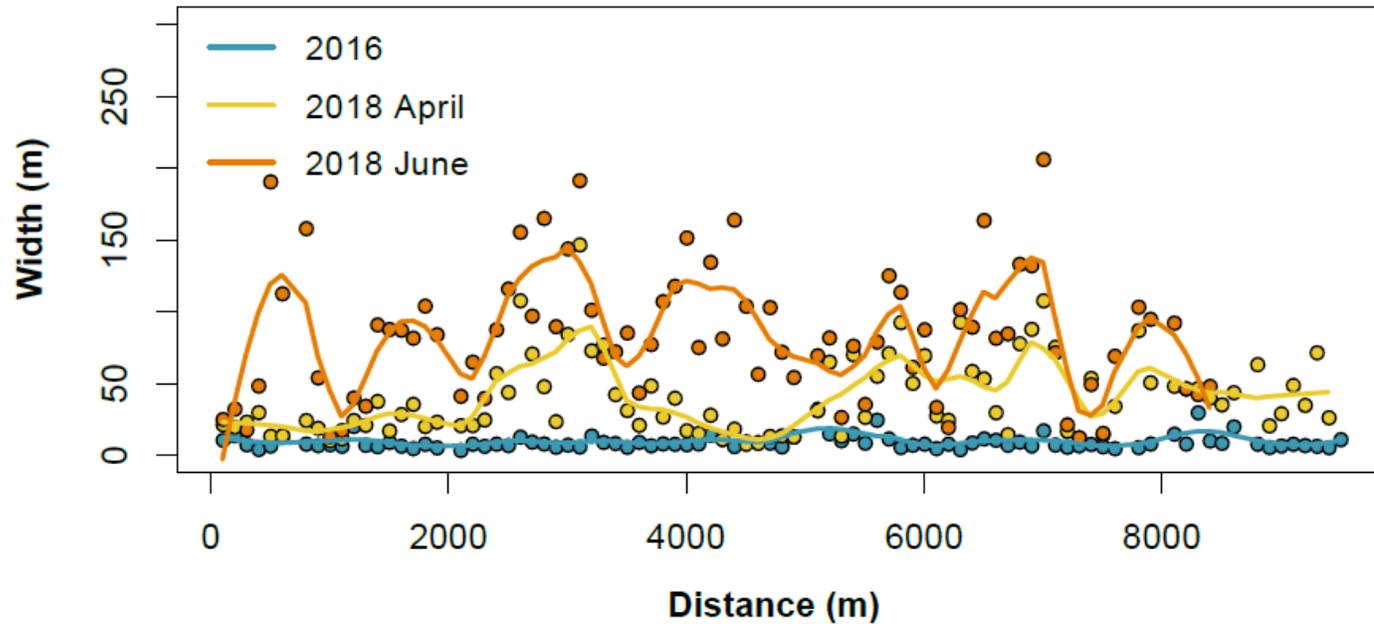
Recap: observed channel change

Average width (Nicola confluence to 8 km upstream)

- 2016: 10.1 m
- 2017: 41.1 m
- 2018: 84.6 m

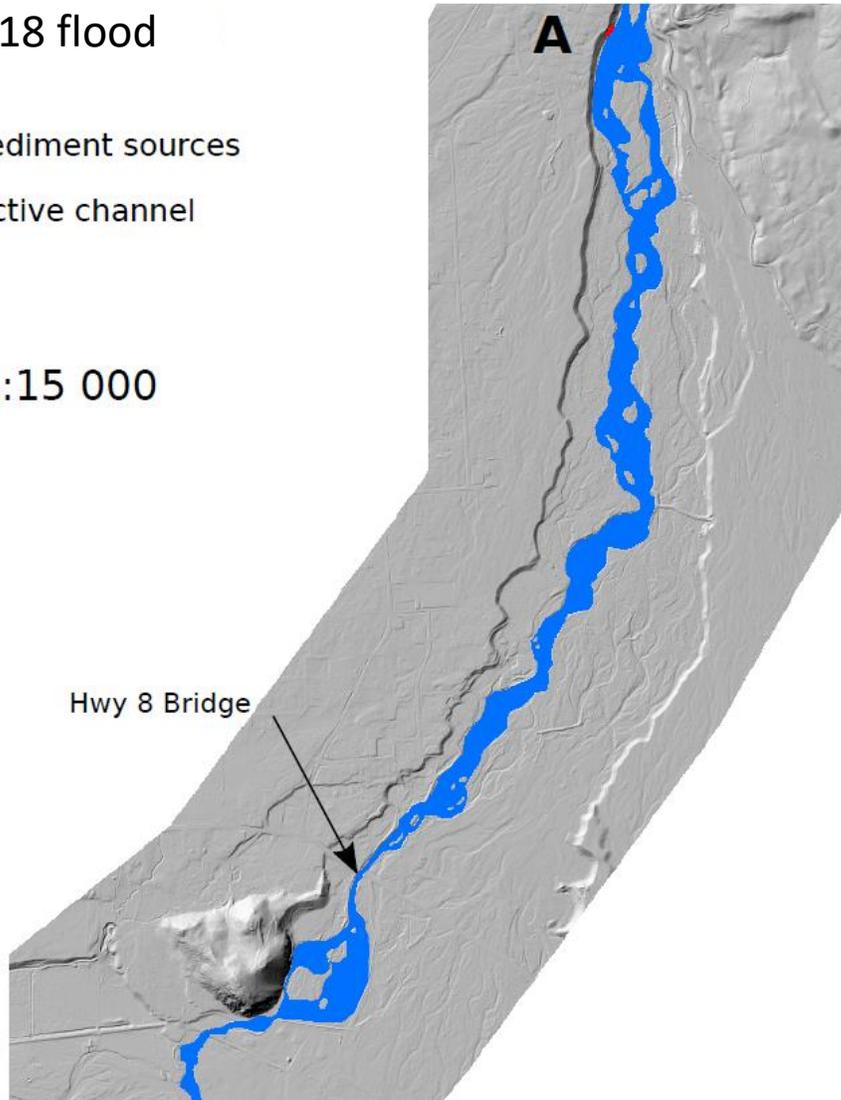
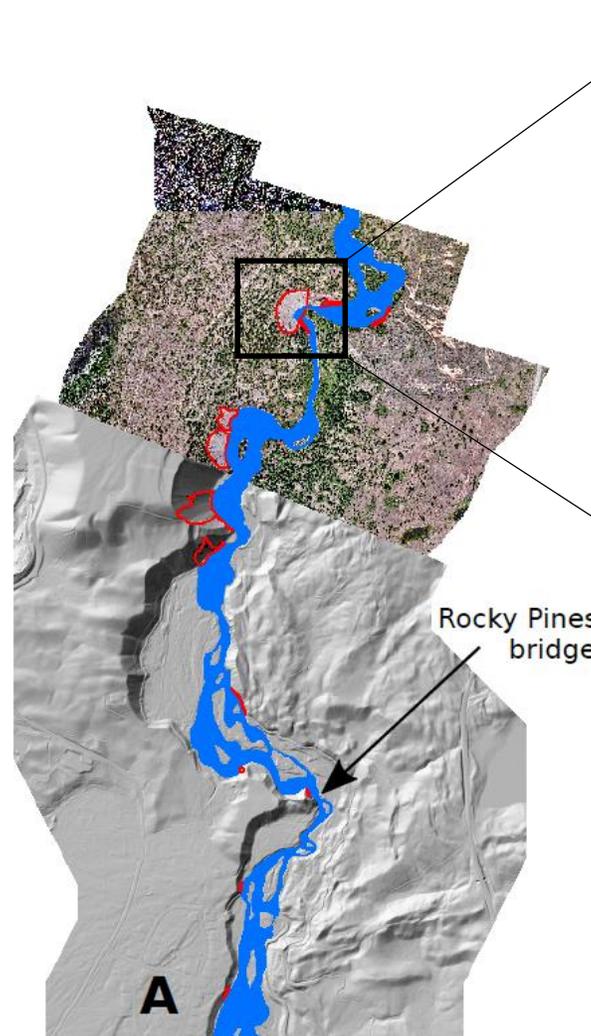
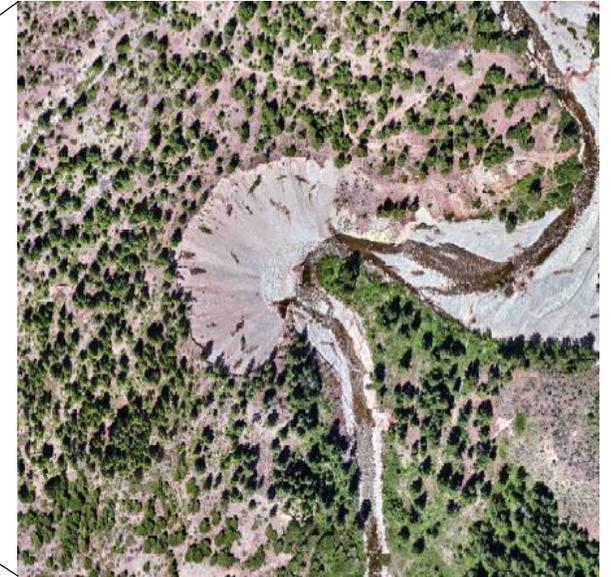
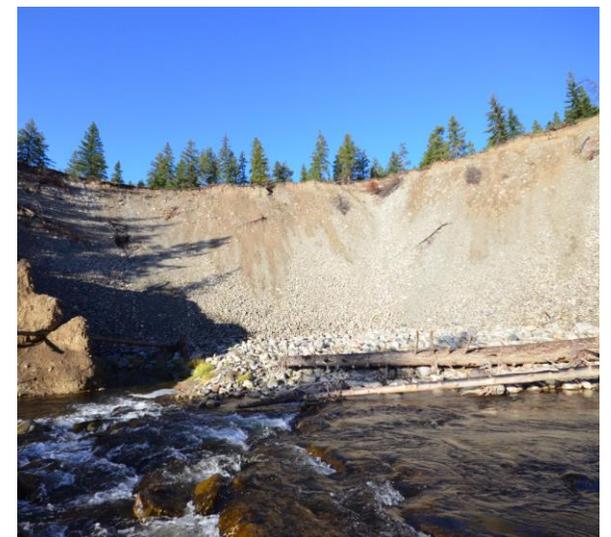
1. Where and how large are the sediment sources?

2018 flood

Sediment sources
-

Active channel

1:15 000
N

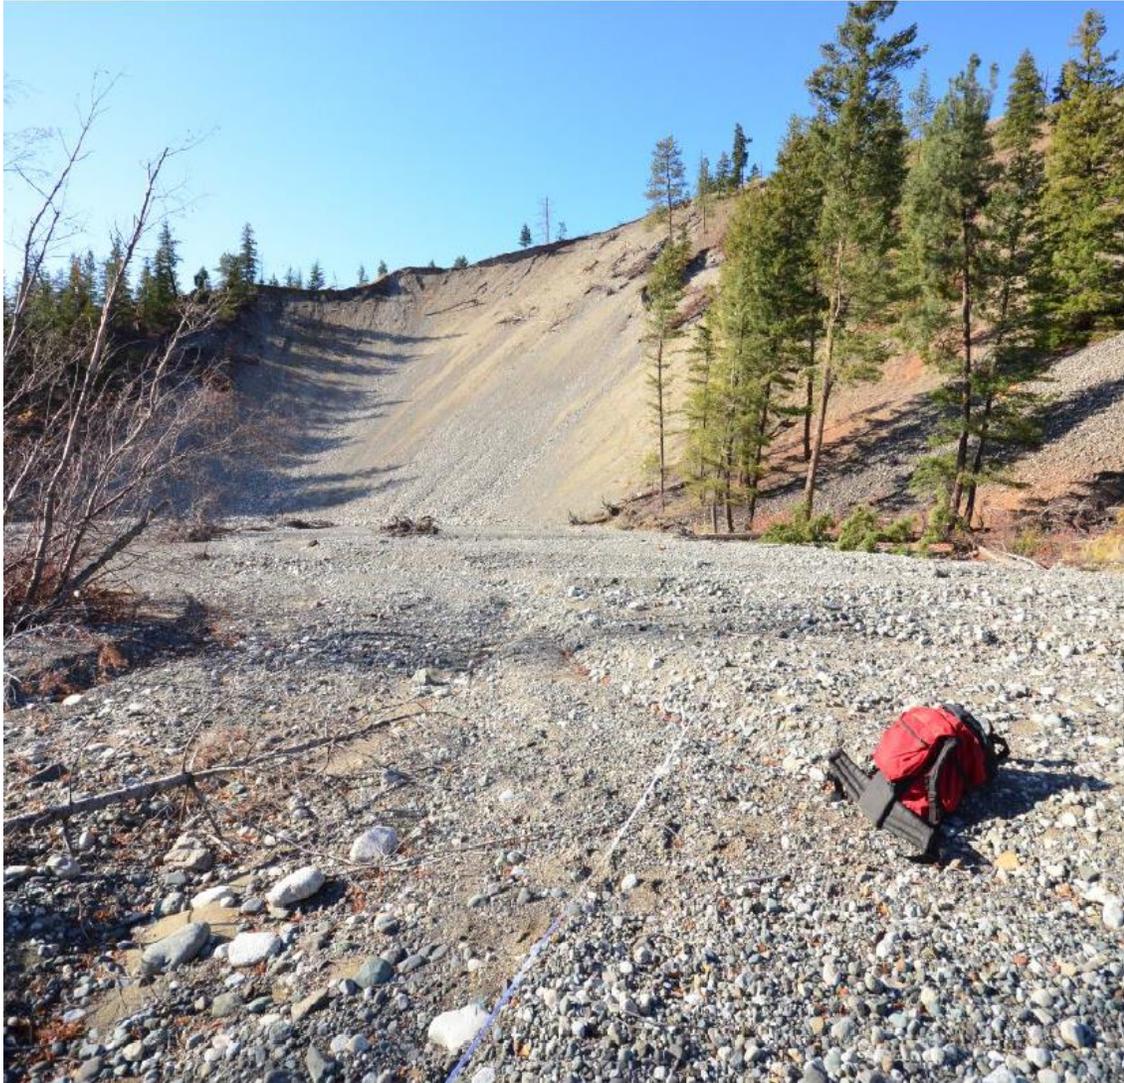
1. Where and how large are the sediment sources?

Sediment yield:

- **2016-2017:** 163,000 +/- 83,000 m³
- **2017-2018:** 63,2000 +/- 6,300 m³
- 22 major sources identified
- 40-60% sand/fine sediment

BUT: limited coverage for 2018 flood, difficulties with floodplain/channel bed erosion identification

These numbers are likely on the low side.

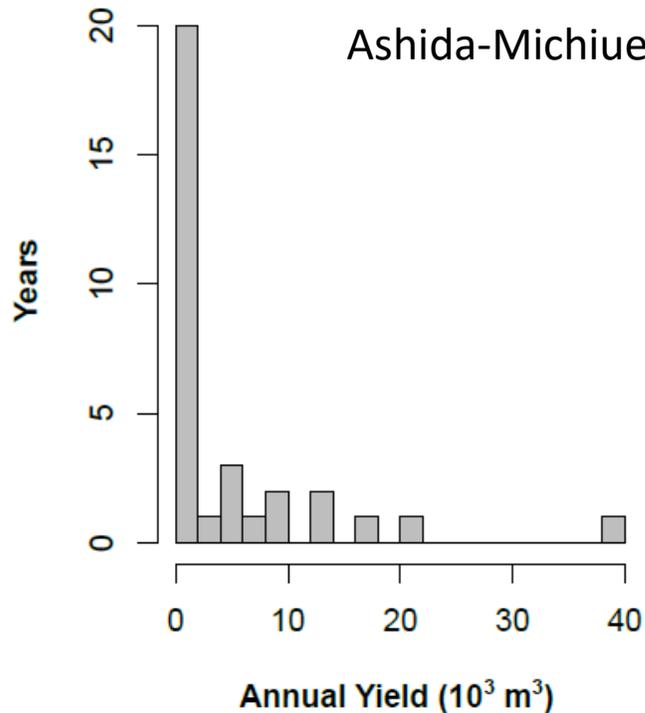
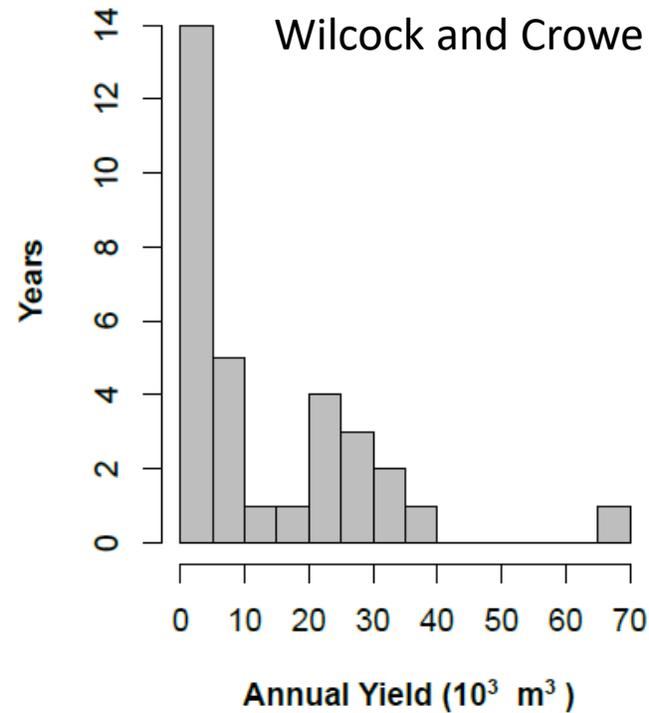
2. Eroded volume vs. background transport rate

Mean annual bedload transport:
4,600 – 13,000 m^3/yr

Median annual bedload transport:
92 – 6,500 m^3/yr

...But probably overestimating true yield

Eroded sediment:

7-500 x the median background rate

3.3-9.7 x the mean background rate

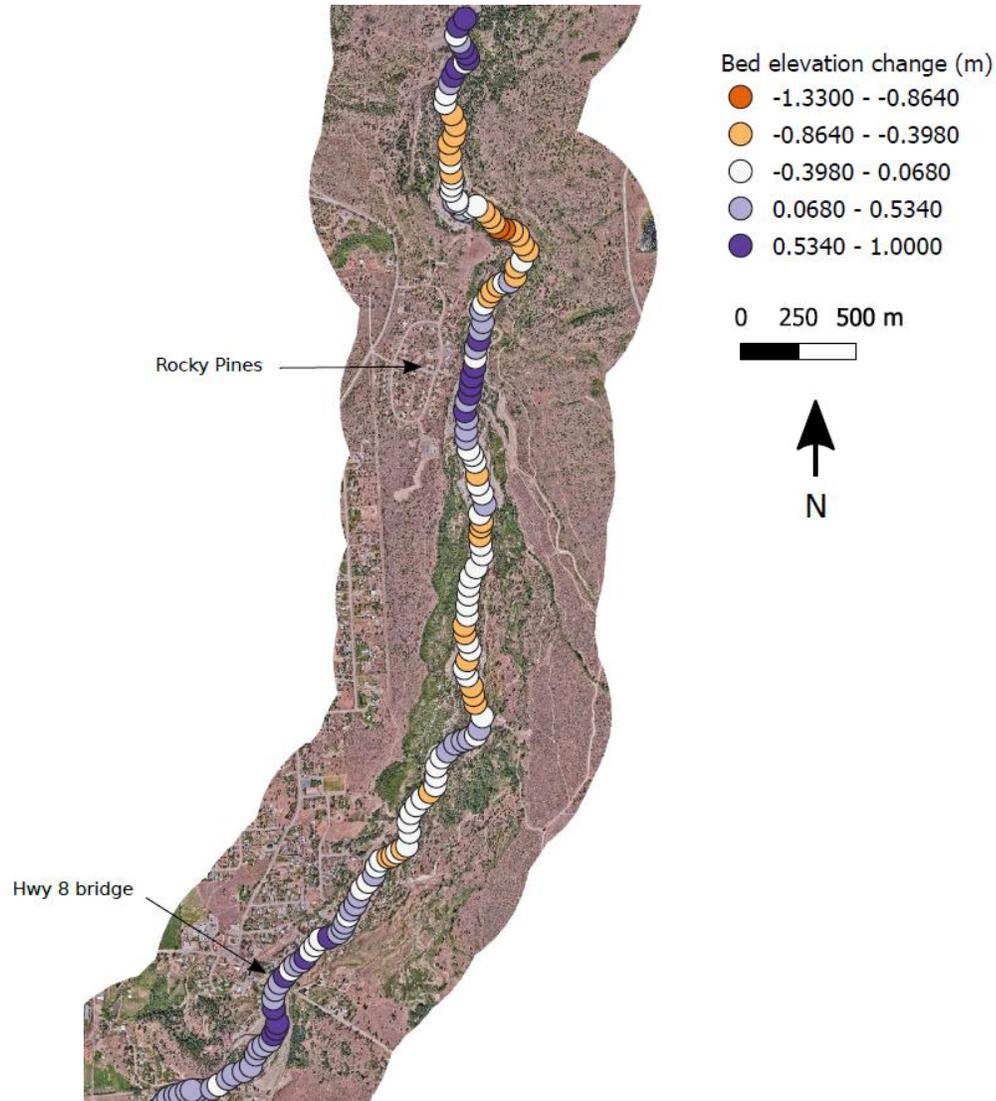
3. How much eroded sediment is depositing downstream?

- **44,500 m³** gain in sediment over region of overlapping Lidar coverage during the 2018 flood
- Equivalent to approximately 70% of the total eroded volume in region of overlapping coverage
- Likely a much smaller fraction of true eroded volume
- Average of **10 cm** increase in channel bed elevation
- Aggradation is not uniform

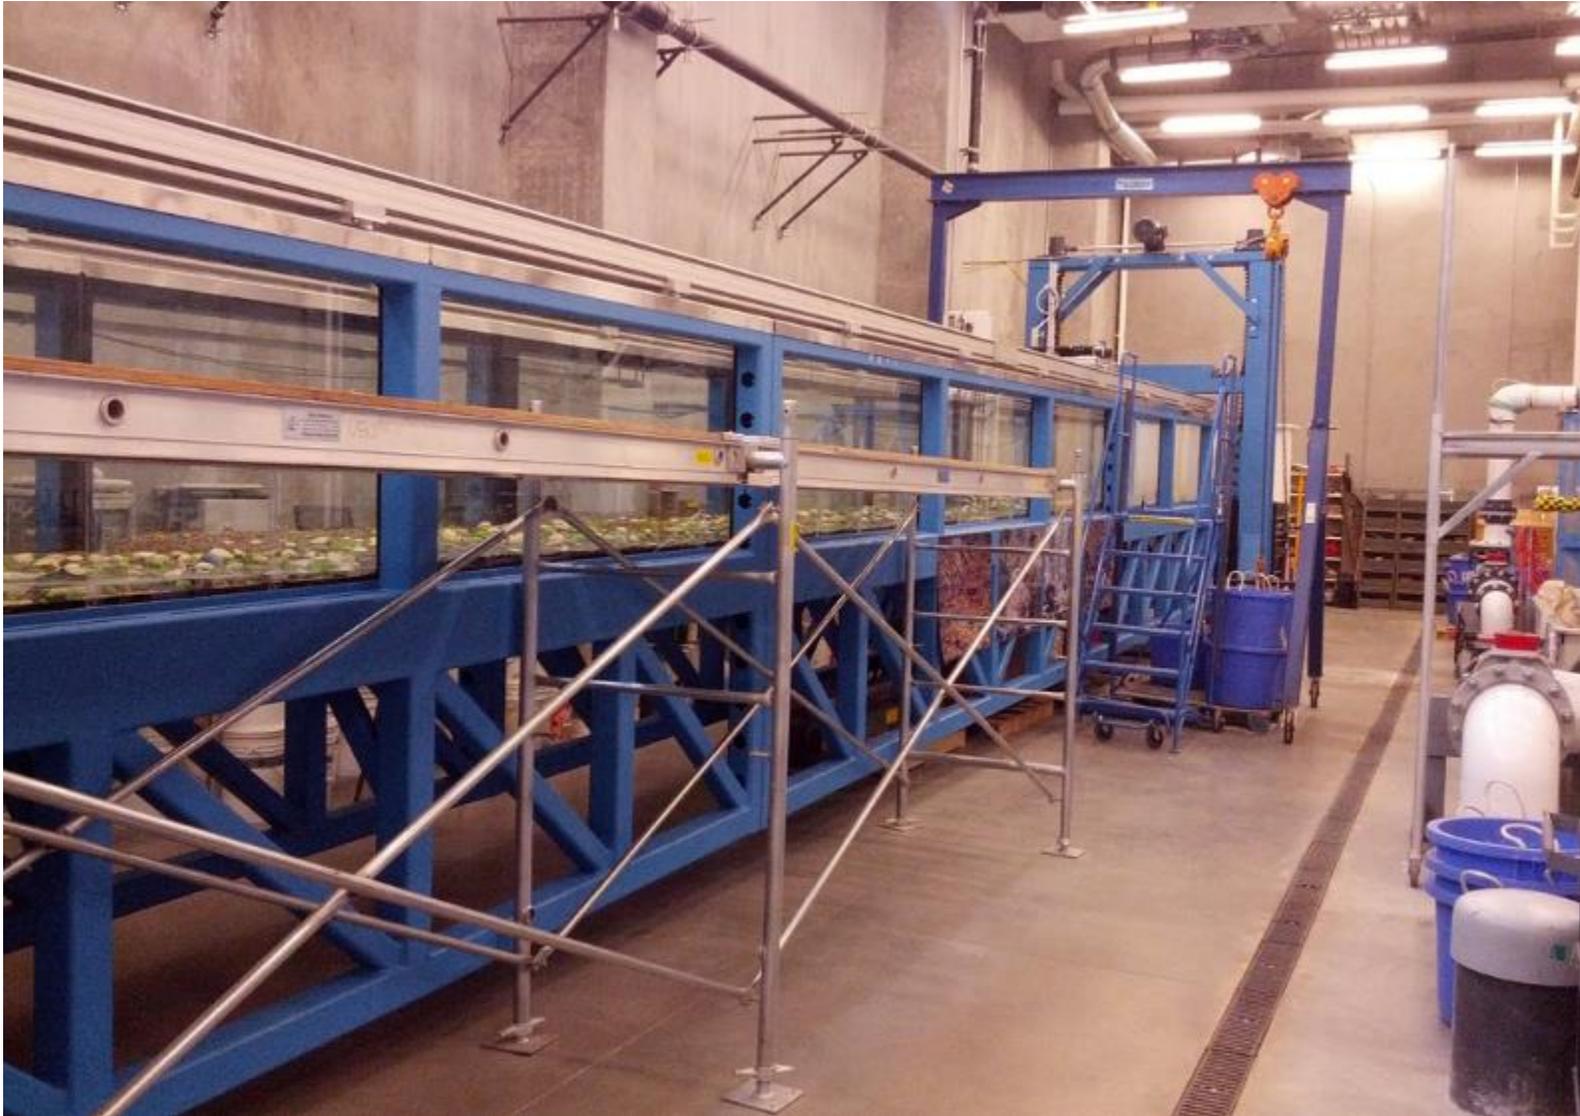
Physical modeling - experiments

Marwan Hassan (another UBC geomorphologist) wants to replicate Guichon Creek sediment impacts in an experimental setting
