- For important limitations, please see *Hydraulic Modelling and Mapping in BC's Lower Mainland Final Report* prepared for Fraser Basin Council by Northwest Hydraulic Consultants Ltd. (2019).
  This map is for information only and intended for flood scenario comparison and flood mitigation planning. The map may also be informative for emergency planning. It is not to be used for designating floodplains, establishing flood construction levels, designing dikes or other structures.
  In cases where dike crests overtop, it is assumed that these dikes remain intact. Since most dikes would likely fail under such circumstances, actual inundation extents and depths may significantly exceed those shown.
  Dike crest elevations are based on a combination of survey data and Lidar. The quality of the data varies and the hydraulic model and associated mapping will require updating once more accurate dike crest information becomes available.

Location	Boundary Condition (Peak Flow/Level)	AEP/Event
Fraser River at Hope	17,000 m <sup>3</sup> /s	1894 Freshet Event
Harrison Lake Inlet	2,050 m <sup>3</sup> /s	1894 Freshet Event
Tributaries	1,424 m <sup>3</sup> /s	1894 Freshet Event
Ocean Level	2.00 m

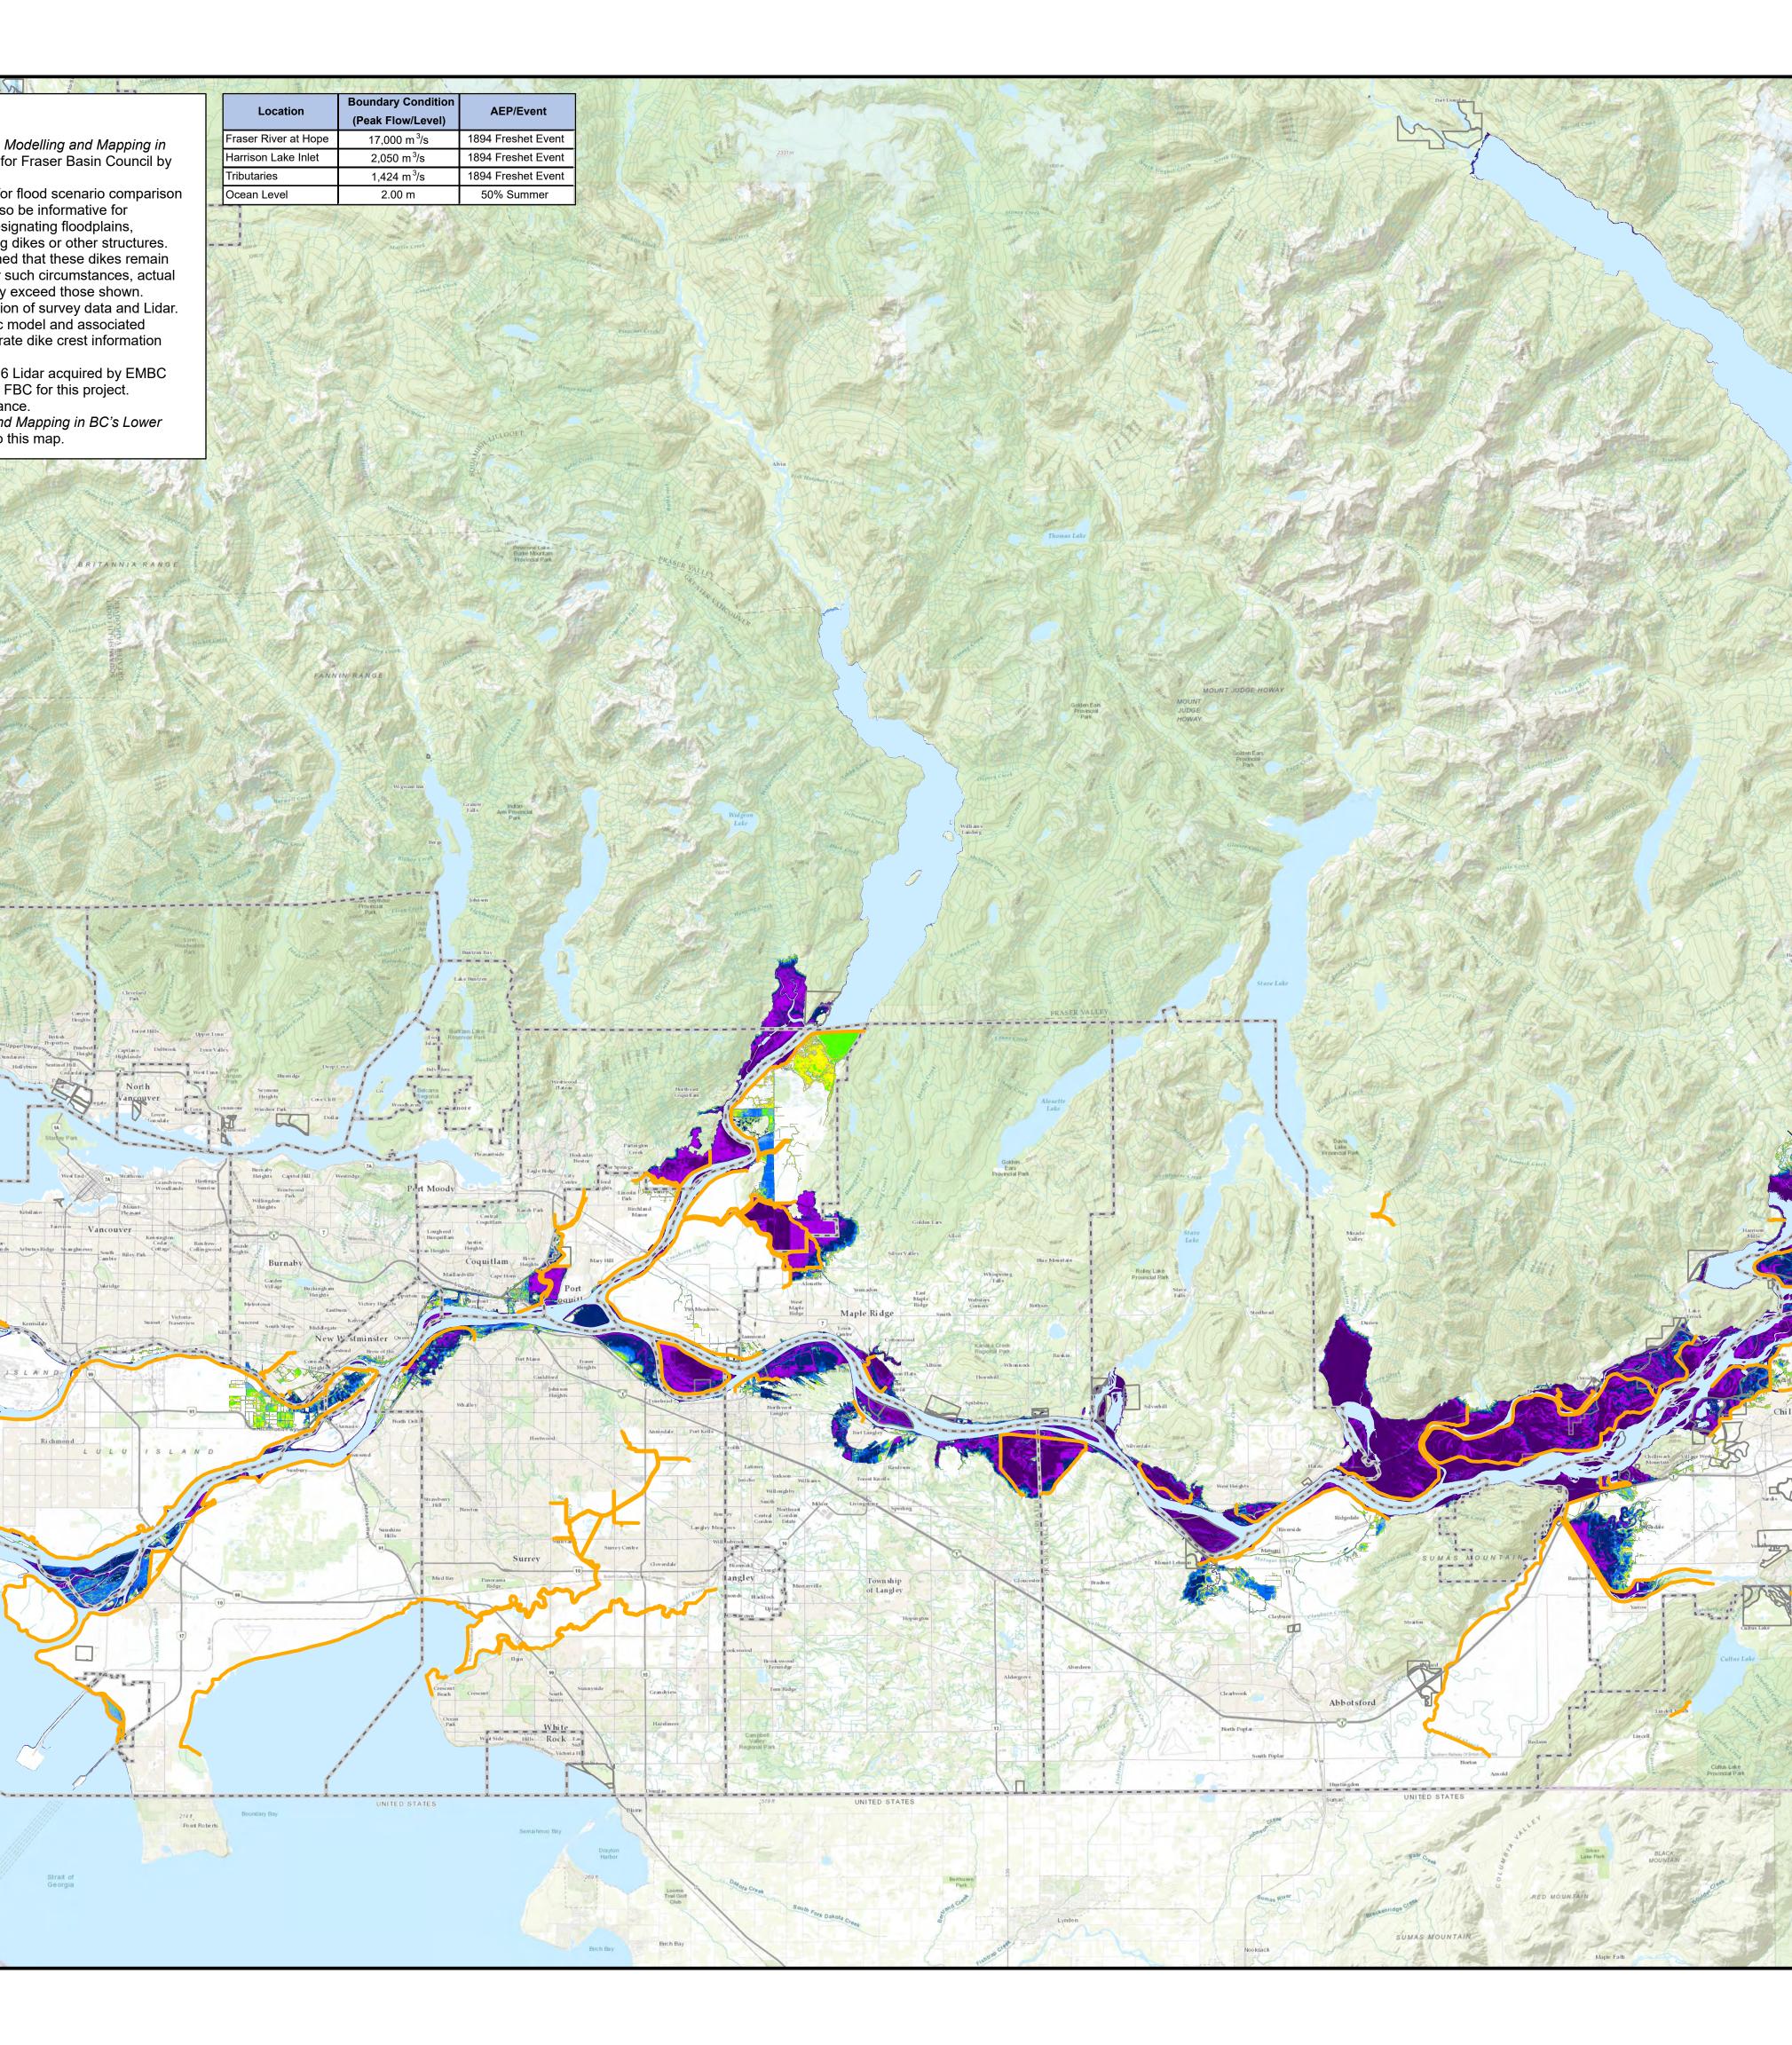
The Digital Elevation Model was based on 2016 Lidar acquired by EMBC
- 5. The Digital Elevation Model was based on 2016 Lidar acquired by EMBC and 2017 bathymetric survey data acquired by FBC for this project.

6. Flood depths do not include a freeboard allowance.
  7. NHC's **Disclaimer**, see *Hydraulic Modelling and Mapping in BC's Lower Mainland Final Report* (2019), also applies to this map.

eptn (m)			
	0 - 0.1	most buildings are dry; underground infrastructure may be flooded	
	0.1 - 0.3	most buildings are dry; walking in moving water or driving is potentially dangerous; underground infrastructure may be flooded	
	0.3 - 0.5	most buildings are dry; walking in moving or still water or driving is dangerous; underground infrastructure may be flooded	
	0.5 - 1.0	water on ground floor; underground infrastructure flooded; electricity failed; vehicles are commonly carried off roadways	
	1.0 - 2.0	ground floor flooded; residents and workers evacuate	
	2.0 - 3.0	ground floor flooded; first floor covered by water; residents and workers evacuate	
	> 3.0	first floor and often higher levels covered by water; residents and workers evacuate	
	Dike		
	First Nation Reserve Boundary		
	Municipal Boundary		
	River, Lake, Ocean or Other Waterbody
